An AC/DC radio which had seen better days.

A short story about the resurrection of an abused EKCO model U29 By Richard Allan

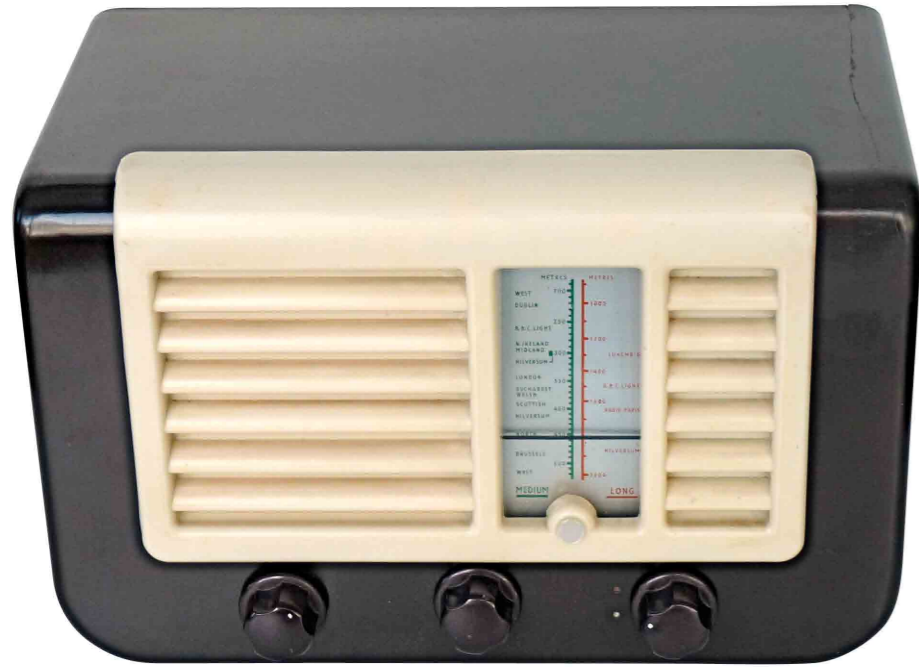
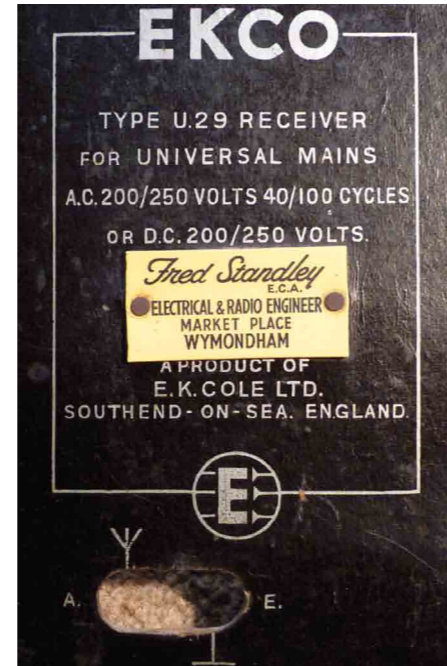
This valve radio was in a poor condition when it was given to me, the case was broken and the greater part of the right hand side was absent and there were cracks in the rest of the case. It was complete with knobs, back and valves, though the mains lead and little logo from the front were missing. Short of making a new case for it I wondered whether it was worth doing anything with at all except for salvaging the valves and one or two components. I was subsequently given the larger of the missing pieces which can be seen below in position prior to fixing with 'superglue'. A piece of thin aluminium was attached to the inside of the case with double sided adhesive tape and the missing portion was filled with a two part wood filler (which I happened to have) and smoothed and shaped when set. The filler was white so the repair was coated with acrylic paint mixed to be a near match to the brown colour of the original moulding. The finished result, though still not perfect is also illustrated. A small button has been used to cover up the hole where the missing Ekco logo should have been.

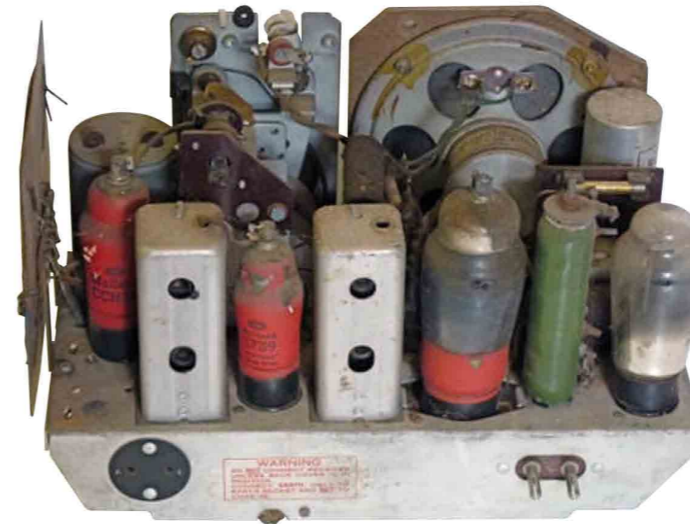
Having repaired the case I then turned my attention to the radio itself. Apart from the dirt and dust on the top of the chassis it was apparent that the dial cord had broken, several wax covered capacitors had been very hot at some time in the past and the wave change switch needed attention to limit the rotation of the wafer. It was also noted that some of

the rubber insulation on the wiring had become very brittle and in a few places had come away. As far as I could tell the only thing that had been replaced was the cathode bypass electrolytic capacitor.

The chassis as received.

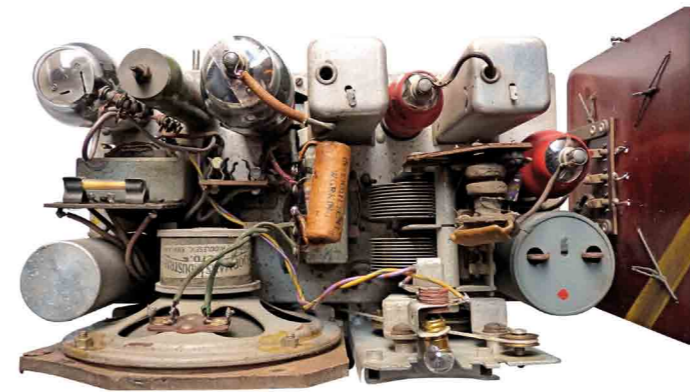
Top of chassis.

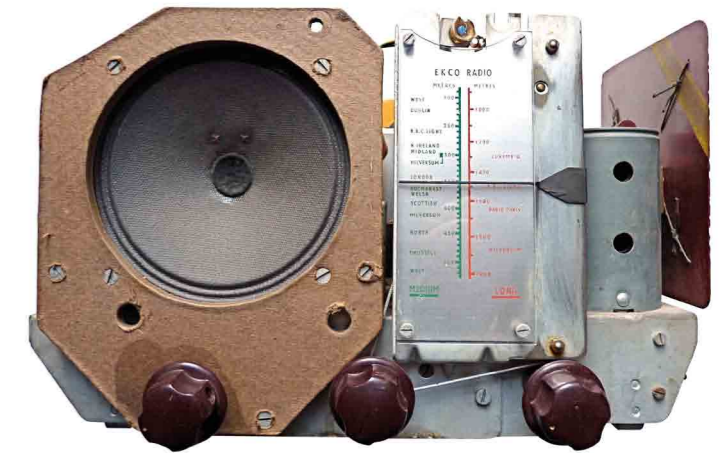
Front of the chassis showing the dial mechanism with new drive cord.

The whole scale and drive assembly has to be removed to replace the cord. After removing the dial lamp holder, two set screws on the tuning capacitor shaft have to be slackened, three screws at the rear and two at the front then have to be removed to do this. One of the two screws at the front can be seen below the scale on the front view of the chassis and two of the three rear screws can be seen either side of the dial lamp on the rear view of the chassis. Before re-assembling I took the opportunity to carefully clean the scale and lubricate the pulleys.

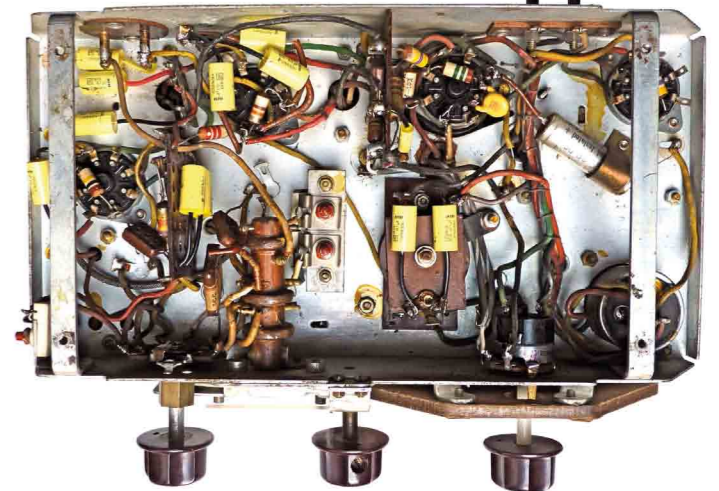
Chassis showing new capacitors, volume control and new screened wiring.

but as this is a universal set a double pole switch is essential. With some ingenuity I managed to fit the 1 megohm track into the housing of a similarly sized potentiometer with a double pole switch. As this was a smaller unit than the one originally fitted I had to remove the locating pip and solder a replacement on the case to match up with the original hole in the chassis. I also soldered a small piece of bent copper to the wave change switch to prevent movement of the wafer beyond the stops.

The set was to test me further, for when I had it all assembled in its now shiny case complete with knobs and back, it steadfastly remained silent. I found that there was no signal getting to the grid of the output valve and this was because the rubber insulation in the screened lead to the top cap had perished and the grid was effectively earthed. This and the screened lead from the preceding stage was replaced, but in doing so I had inadvertently disturbed the insulation on the wiring to the heater ballast resistor and it had decided to touch the chassis, blow one of the fuses and the dial lamp when next I switched it on. After replacing this, the wires to the dial lamp the fuse and 6 volt dial lamp the

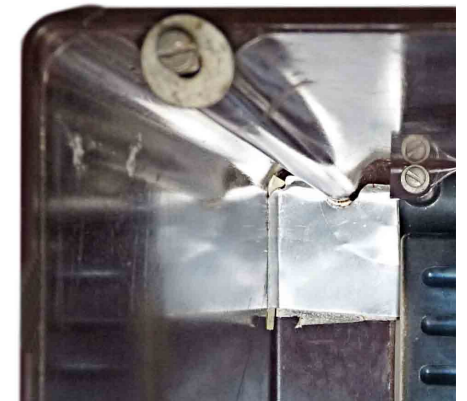
Inside showing support for filler.
